## Effect of small gap between tube and suction box on crevice corrosion formation of the dewatering tube

Dewatering tube is a crucial equipment used to separate water and solids during papermaking process. The tube made of SS 316L stainless steel, responsible for supplying fresh water, failed during operation. The purpose of this research was to determine the cause of failure to prevent similar issues in the future. Methods used in this research mainly implements root cause analysis while considering all possible aspects contributing to the failure. Pitting Resistance Equivalent Number of 23.499 was obtained, indicating acceptable value of SS 316L localized corrosion resistance. However, the results of the examination indicated that the failure of the dewatering tube was caused by crevice corrosion. The crevice corrosion was formed due to trapped chlorine-containing water in the gap between the tube and suction box. The chlorine content of 3.36 wt% was confirmed by EDS. The presence of chlorine deposits in the gap between suction box, in combination with operating temperature (70 – 80°C) and environment (pH 3.5 to 4.5) caused the localized corrosion reaction to occur, ultimately

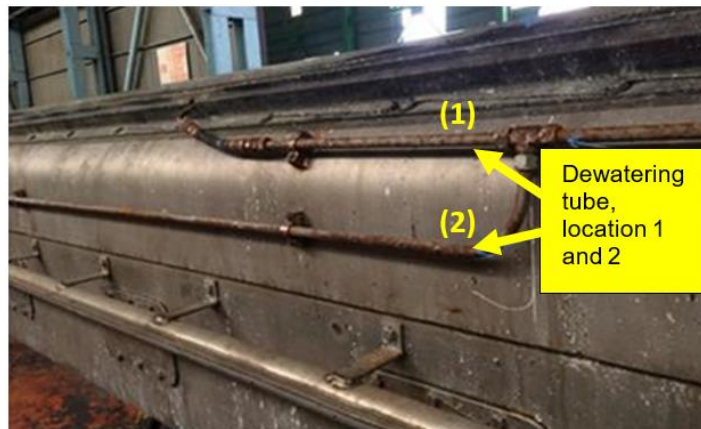
**Figure 1.** Location of the tube examined in the laboratory to determine the root cause of the failure. Tubes on location 1 and 2 are attached on the same suction box.

In this research, the failed tube was clamped to the suction box with an approximate 2 mm gap in between (Figure 1). The presence of such narrow gaps between the suction box and the tube can lead to localized corrosion at this site (Figure 10) [11].

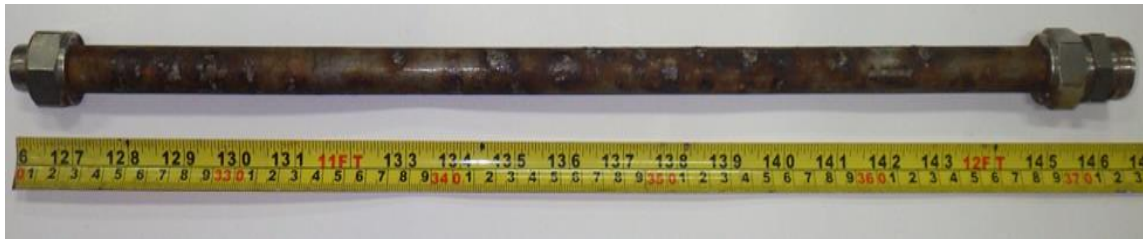
The visual examination clearly shows that the investigated tube is heavily corroded by general corrosion on its outer surface, as depicted in Figure 2.

**Figure 2.**  
Visual examination of the failed tube (Location 1) reveals that the majority of the outer surface is covered by corrosion products.

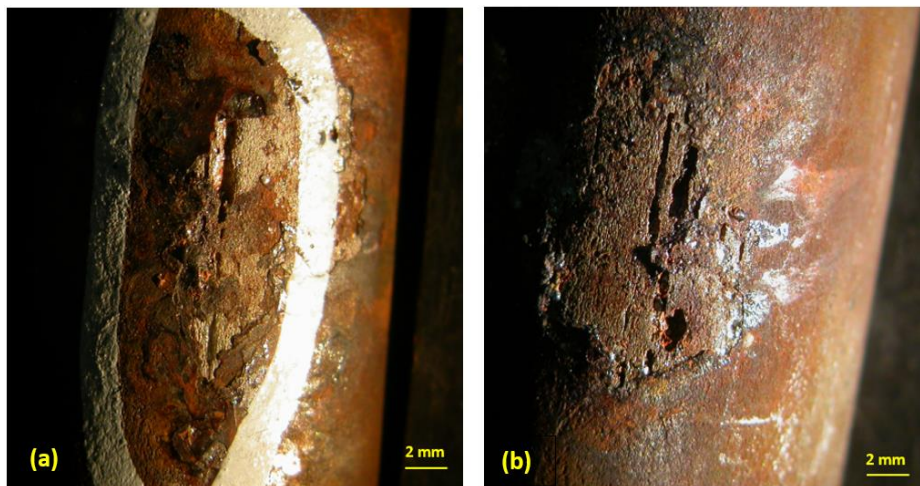
Higher magnification of specific areas facing the suction box either at location-1 or location-2 reveals evidence that the corrosion process has penetrated the tube's thickness, forming longitudinal notches. These notches are present at multiple observation locations, as shown in Figure 3.

**Figure 3.**  
Observation of notches on the tube surfaces at different locations facing the suction box: (a) Location 1 and (b) Location 2.

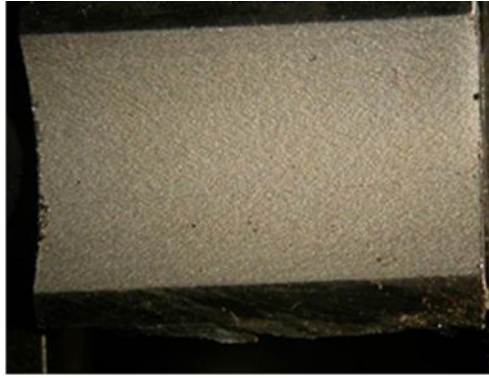
However, no corrosion products or crevices are found on the inner tube surface, which remains clean and in good condition (Figure 4).

**Figure 4.**  
Visual examination of the inner tube surface shows no corrosion products and it remains in good condition.

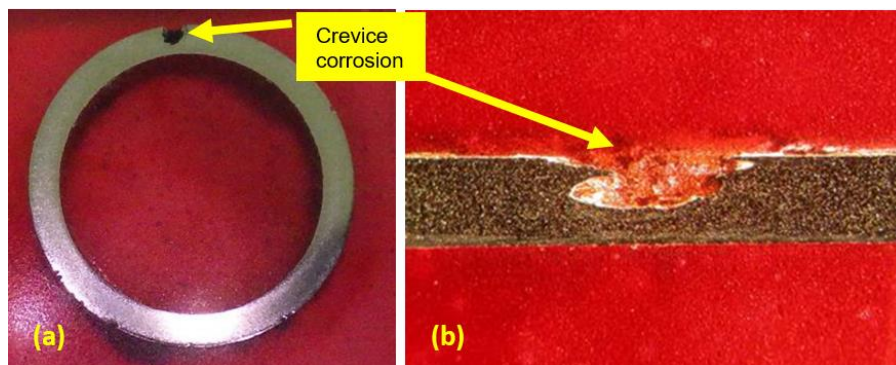
Macrographic examination of the cross-section at location-1 confirmed that the notches originated from the outer surface of the tube, as depicted in Figure 5a.

**Figure 5.**  
Cross-sectional examination of the tube at Location 1 (a) and longitudinal section at Location 2 (b) reveal the formation of notches originating from the outer surface.

A similar phenomenon occurred on the longitudinal section of location-2, which was also facing the suction box (Figure 5b). These observations confirm that the main cause of failure originated from the outer surface of the tube, while the inner surface remains free from corrosion and in good condition. There is no evidence of thinning or leakage caused by other mechanisms such as mechanical impact, overloading, erosion, bulging, or thermal deformation. Therefore, the primary cause of failure appears to be the formation of a crevice on the outer surface [11, 12].

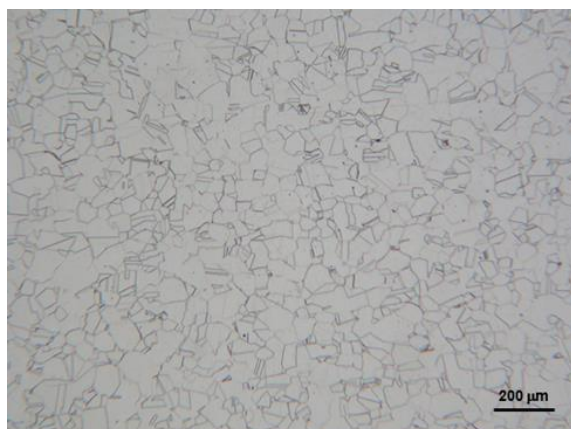
The metallographic examination of the bulk area revealed that the microstructure of the tube is austenitic, which is typical of 316L stainless steel (Figure 6) [11]. Therefore, the failure of this tube cannot be attributed to incorrect material selection. Further examination of the microstructure at the leakage area confirms that the notch was formed on the outer surface of the tube.

**Figure 6.**  
Microstructure of the bulk tube material is austenitic, it is in accordance with 316 L stainless steel microstructure.

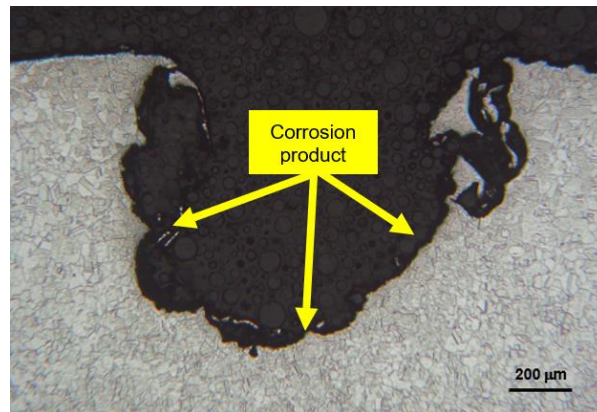
There is no evidence indicating that the formation of the notch was caused by mechanisms such as erosion or mechanical impact, other than crevice corrosion. This is supported by the presence of black deposits on the notch surface and the observation of truncated grain structure along the notch surface (Figure 7).

**Figure 7.** Higher magnification using metallography technic revealed that the notch area is covered by corrosion products.

Moreover, the wide and deep dimensions of the notch contour are typical of crevice corrosion attack [7, 12, 13]. Microstructure examination revealed no indications of other contributing factors to the leakage, such as microcracks, inclusions, or micro defects.

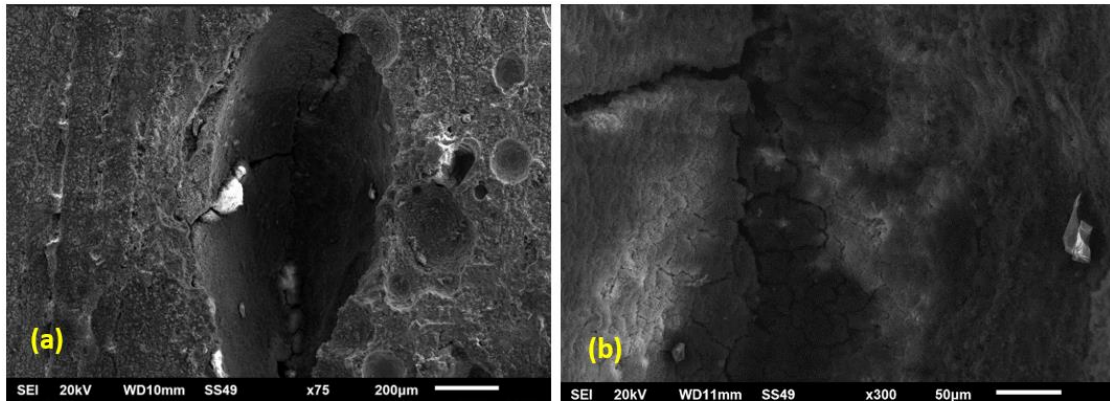
**Figure 8.**

Crevice evidence was also observed using Scanning Electron Microscopy (SEM), which revealed a wide and deep notch characteristic of crevice failure and the crevice wall is covered by corrosion product (Figure 8 a and b). Energy Dispersive X-Ray (EDX) analysis of the black deposits on the notch surface indicated high oxygen content and identified the presence of corrosive chlorine (Cl) on the surface. It is confirmed that the deposit on the notch surface is a corrosion product (Figure 9 and Table 4).

Scanning Electron Microscopy (SEM) examination of the notch area shows that the notch is characteristic of crevice corrosion (a) and the crevice wall is covered by corrosion product (b).

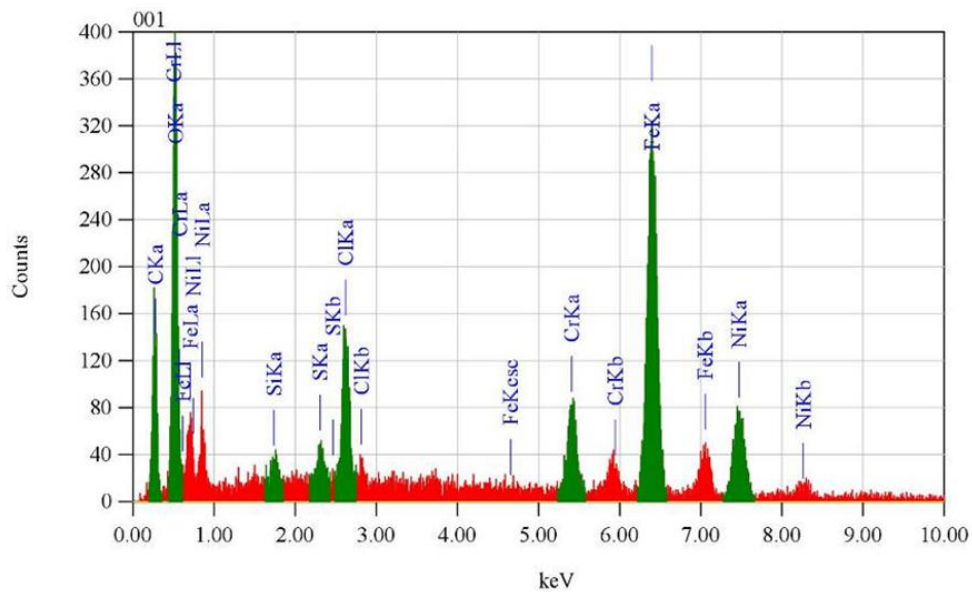
Figure 9 Energy Dispersive X-Ray (EDX) analysis of the notch surface indicates high oxygen content, representing corrosion products, and reveals the presence of the corrosive element chlorine (Cl).

Element	Mass %
C	22.46
O	29.19
Si	0.50
S	0.64
Cl	3.36
Cr	4.72
Fe	29.04
Ni	10.10

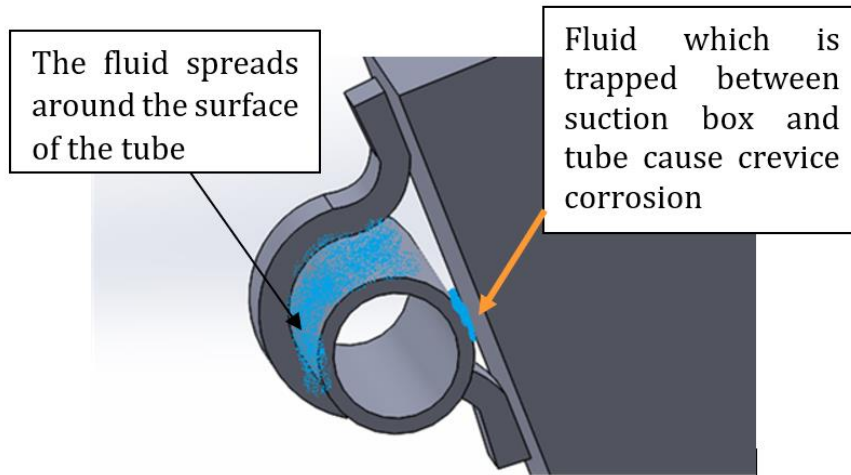
**Figure 10.**  
Fluid trapped between the tube and the suction box promote localized corrosion reaction.

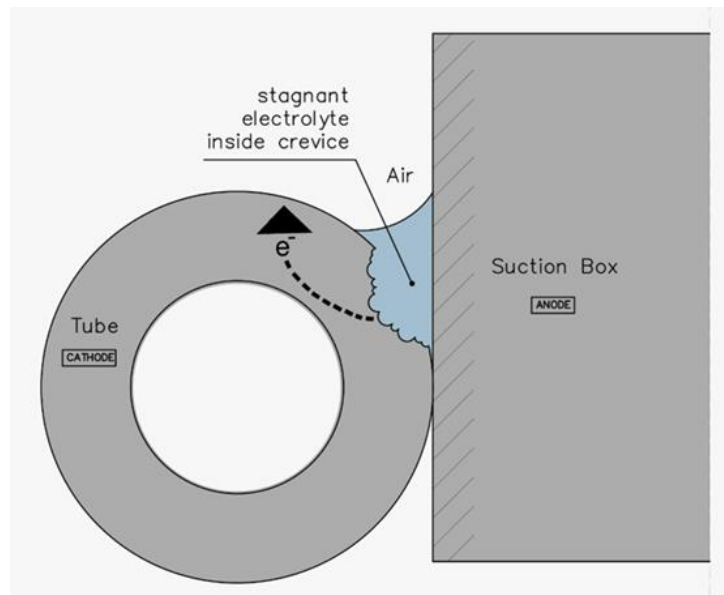
Crevice corrosion can occur when water splashed from the dewatering process, along with dirt, becomes trapped in these narrow gaps, leading to the breakdown of the passive surface layer within the crevices or shielded areas. The common mechanism behind all types of crevice corrosion is the development of a localized environment that can differ significantly from the bulk environment, often resulting from the establishment of oxygen differential cells. Oxygen ingress in the process and production system can be detrimental to corrosion-resistant alloys. This occurs when oxygen within the crevice electrolyte is consumed, while the surrounding exposed surface has ready access to oxygen and becomes cathodic relative to the crevice area (Figure 11) [18, 19].

**Figure 11.**  
The role of oxygen in the initiation of crevice corrosion on the tube.
