## Effect of small gap between tube and suction box on crevice corrosion formation of the dewatering tube

Dewatering tube is a crucial equipment used to separate water and solids during papermaking process. The tube made of SS 316L stainless steel, responsible for supplying fresh water, failed during operation. The purpose of this research was to determine the cause of failure to prevent similar issues in the future. Methods used in this research mainly implements root cause analysis while considering all possible aspects contributing to the failure. Pitting Resistance Equivalent Number of 23.499 was obtained, indicating acceptable value of SS 316L localized corrosion resistance. However, the results of the examination indicated that the failure of the dewatering tube was caused by crevice corrosion. The crevice corrosion was formed due to trapped chlorine-containing water in the gap between the tube and suction box. The chlorine content of 3.36 wt% was confirmed by EDS. The presence of chlorine deposits in the gap between suction box, in combination with operating temperature (70 – 80°C) and environment (pH 3.5 to 4.5) caused the localized corrosion reaction to occur, ultimately

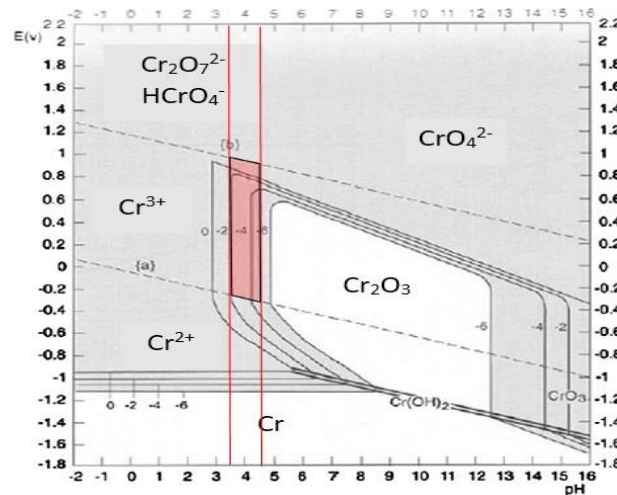
**Figure 12.**

It is well known that a low pH level can reduce the stability of the passive layer on stainless steel, which serves as the corrosion-resistant component. This passive layer is composed of chromium oxide, formed by the oxidation of chromium in the atmosphere. It has a regenerative characteristic, allowing it to automatically recover when scratched. As a result of the reduced stability of this passive layer, stainless steel becomes prone to crevice corrosion, particularly in areas where the electrolyte solution is trapped. When the passive layer is damaged, it is difficult to regenerate a new layer because it cannot come into contact with atmospheric oxygen due to obstruction by the solution. This condition is exacerbated by the fact that the pH decreases further due to the dissolution of chromium in the electrolyte at the crevice location when the passive layer is damaged [20]. Given that the operational pH is between 3.5 and 4.5, it can be confirmed that the passive layer of

SS 316L is in an unstable condition. The Pourbaix diagram for chromium (Figure 12) indicates that, under these conditions, it is difficult to regenerate the passive layer. As a result, crevice corrosion may continue to progress [11].

The Chromium Pourbaix diagram shows that the passive layer ( $\text{Cr}_2\text{O}_3$ ) becomes ionized to  $\text{Cr}^{3+}$  under pH 3.5 conditions Kain [11].

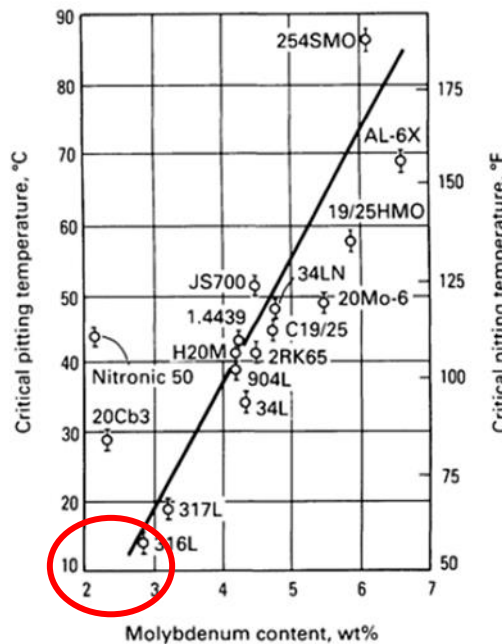
**Figure 13.**

The effect of molybdenum (Mo) on various stainless steels types in an  $\text{FeCl}_3$  environment with critical pitting or crevice Kain [11].

It can be confirmed that the tube investigated, with a 2.03% Mo content and operated at temperatures around  $70\text{--}80^\circ\text{C}$ , is prone to localized corrosion attacks. Additionally, another approach to assess corrosion resistance is through the Pitting Resistance Equivalent Number (PREN), which depends on the chemical alloy content of the material. The PREN can be calculated using the following equation [11]:

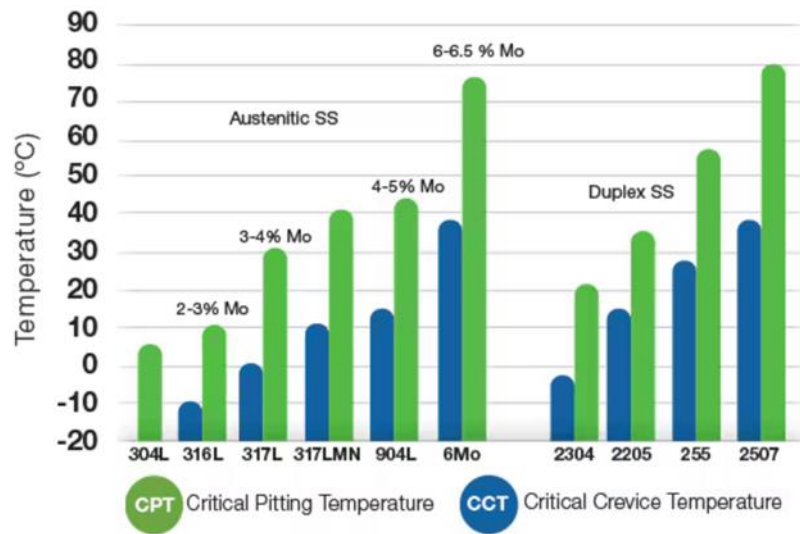
**Figure 14.**

approximately 23.499 which indicates the acceptable value of SS316L pitting resistance. When this data is compared to the critical pitting temperature (CPT) and critical crevice corrosion temperature (CCT), as shown in Figure 14, it is evident that SS316L has low CCT (-10°C). It confirms that crevice corrosion is likely to occur when operating temperature is above CCT. It is important to remember that crevice corrosion can occur at lower temperatures than pitting corrosion because less effort is required to initiate a pit within the geometric crevice [24].

Critical pitting temperature (CPT) and critical crevice corrosion temperature (CCT) for various austenitic and duplex stainless steels, measured according to ASTM G48 in 10% ferric chloride Wei, et al. [4].

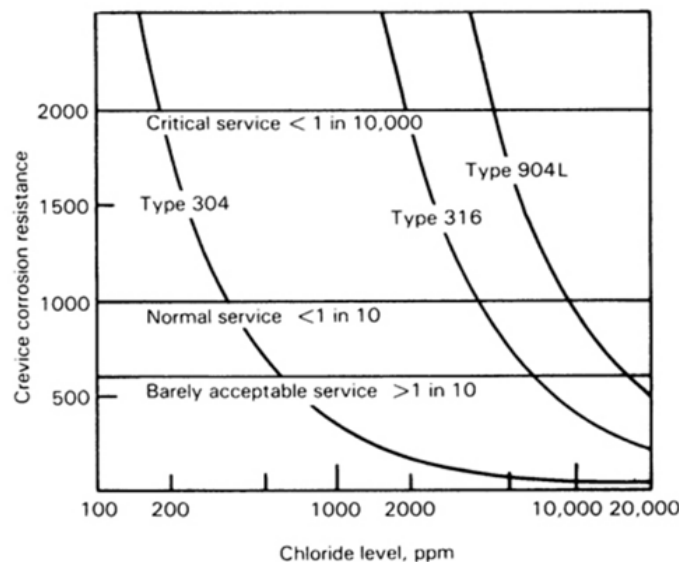
**Figure 15.**

The presence of chloride ions significantly promotes crevice corrosion. Higher chlorine content in the area creates a chemically aggressive environment where corrosion-causing ions cannot readily diffuse out of the crevice. In such conditions, the entire surface within the crevice can corrode at an accelerated rate [25]. As shown in Figure 15, crevice corrosion of 316L stainless steel begins to occur in water with chloride content as low as 2000 ppm.

Probability of crevice corrosion occurring in water containing chlorine Yang, et al. [26].

It is important to consider that the watering system in the pulp industry contains chlorine concentrations and operates at temperatures above the critical passive layer strength of stainless steel. Therefore, crevice corrosion is readily initiated [26-28].
